Norwood Public Schools

Long Range Study Committee

Coakley Middle School

Coakley Middle School - Building Deficiency **Building Performance**

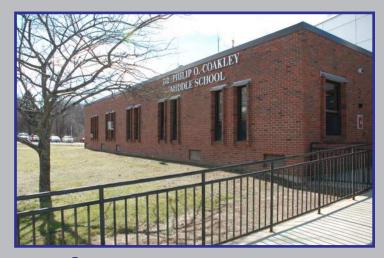
- No major capital investments to improve the building envelope since its construction 42 years ago
- No insulation has been added to the roof, which will need to be replaced in the next 5-10 years
- No cavity between the brick/masonry back-up exists; potential moisture infiltration issue, plus only 1" insulation when 3"+ is best

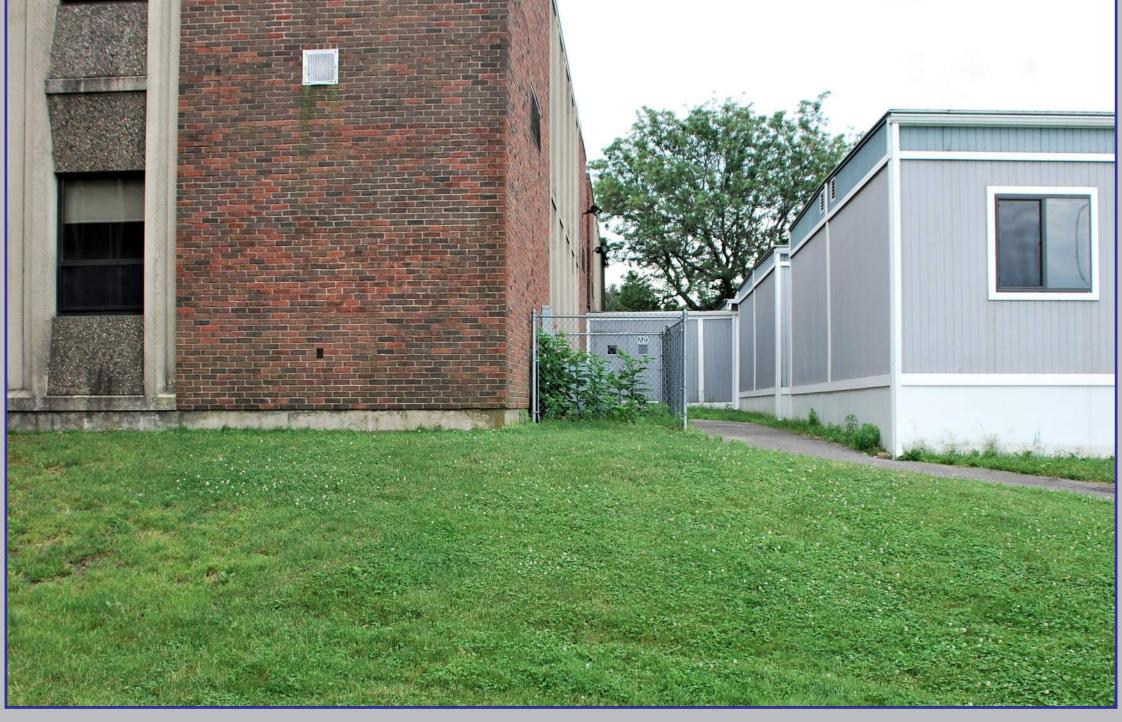
- **No** major capital investments to improve the building envelope since its construction 42 years ago
- **No** insulation has been added to the roof, which will need to be replaced in the next 5-10 years
- **No** cavity between the brick/masonry back-up exists; potential moisture infiltration issue, plus only 1" insulation when 3"+ is best

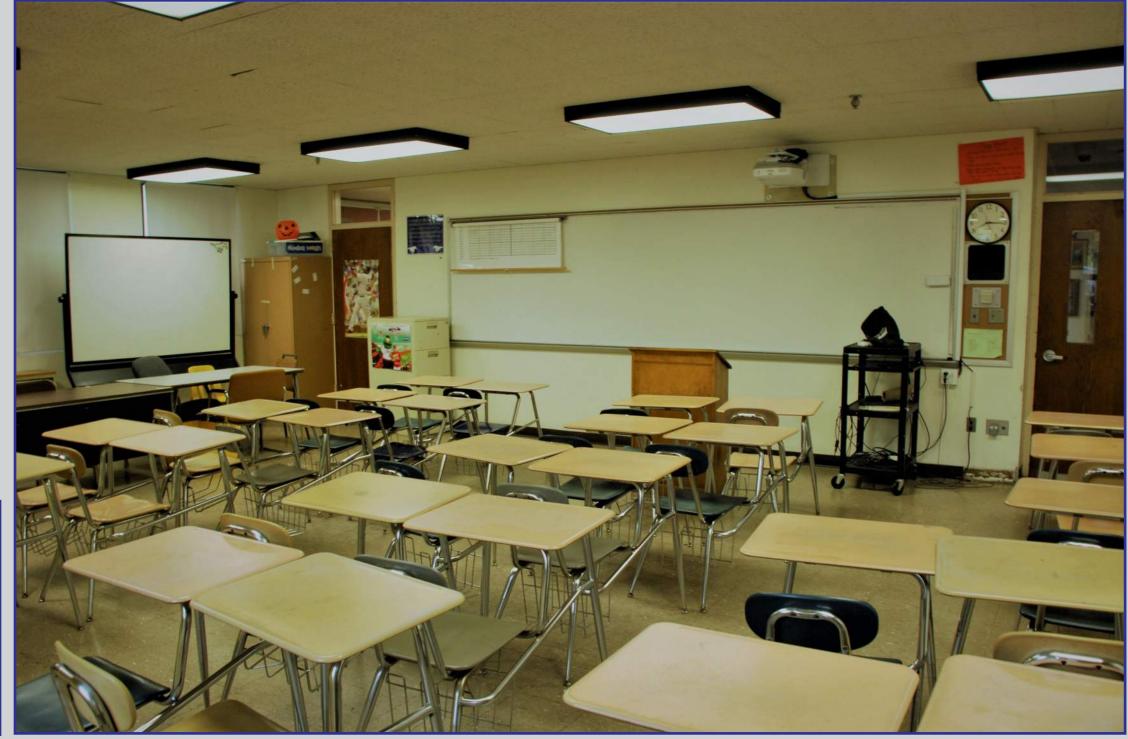
Coakley Middle School - Functional Deficiency

- **No** ability to logically organize classes into academic neighborhoods
- **No** sufficient storage space per classroom
- **No** interaction with the outdoors and little space available for arts/language
- **No** appropriately sized core classrooms

- ✓ Academic neighborhoods facilitate team teaching, way-finding, and provide a sense of community or team within the larger school setting
- ✓ Layouts are structured to include sufficient storage and furniture that is flexible for varied lesson plans

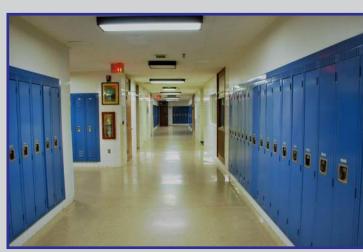
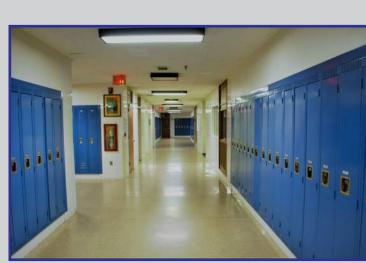
- No sign of connectivity or transparency; materials show signs of degradation and suggest that classrooms are prohibited
- No opportunity for display or flexible space because student storage consumes the corridors
- No sense of identity or life within the corridors

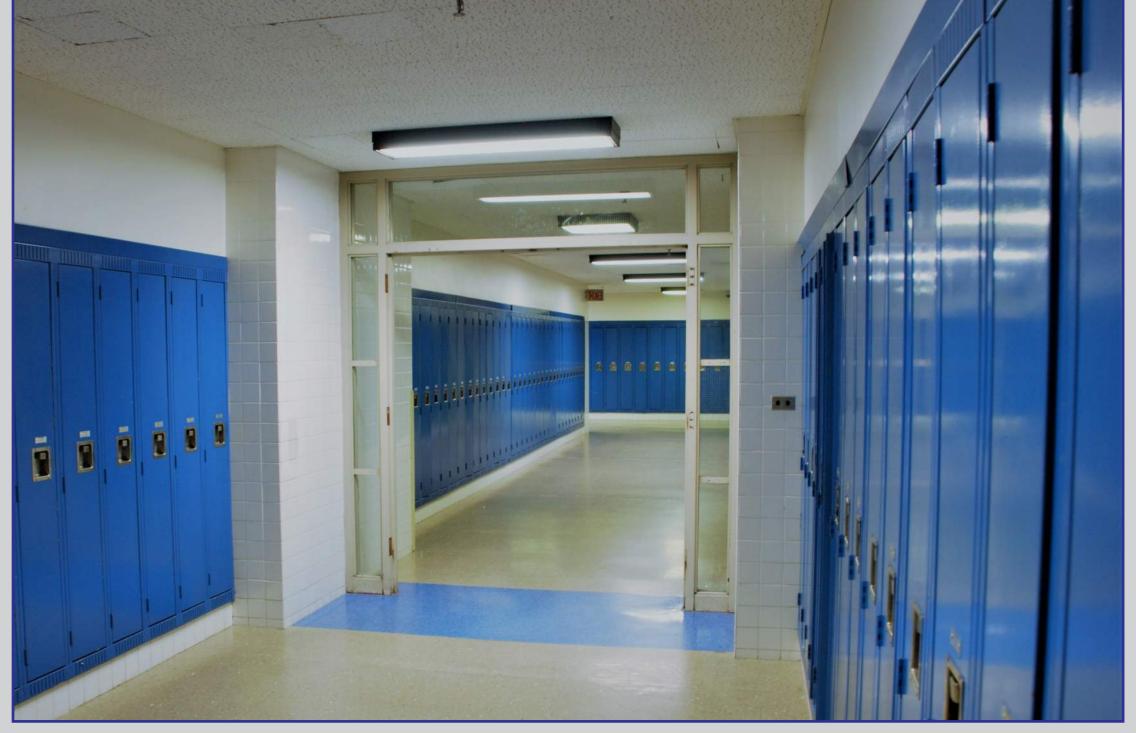
Coakley Middle School - Educational Deficiency Transparency & Personalization

- No sign of connectivity or transparency; materials show signs of degradation and suggest that classrooms are prohibited
- No opportunity for display or flexible space because student storage consumes the corridors
- No sense of identity or life within the corridors

- ✓ Modern, welcoming classroom entries that serve to showcase the learning and activity within
- ✓ Student storage is integrated in a fun and functional manner
- ✓ Corridors and classrooms are bright and contain elements that personalize the school

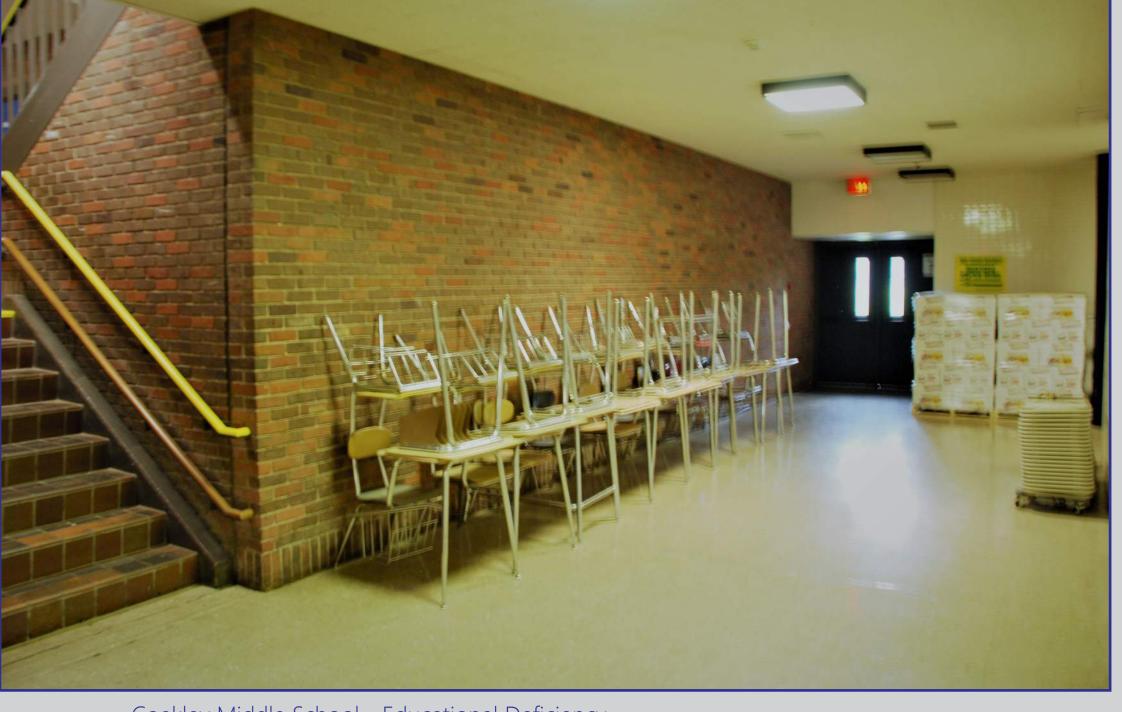
- No appropriately sized collaborative work spaces for either students or staff
- No visual relationship between the core classrooms and collaborative work spaces
- No furniture to accommodate flexible group settings or varied layouts

• No small group rooms, resource rooms, tiered lecture spaces, or learning labs

- ✓ Spacious, available collaboration space that creates a positive link between teacher and student
- ✓ Collaboration spaces that are easily accessed and visible from classrooms
- ✓ Varied work settings that better assist a multitude of learning types
- ✓ Opportunities for solo or group work

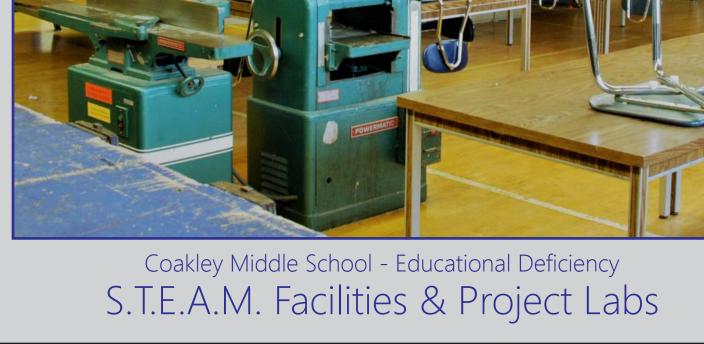
FAIL Existing Education Design:

2,704 sf

existing avg

6,400 sf

recommend. avg

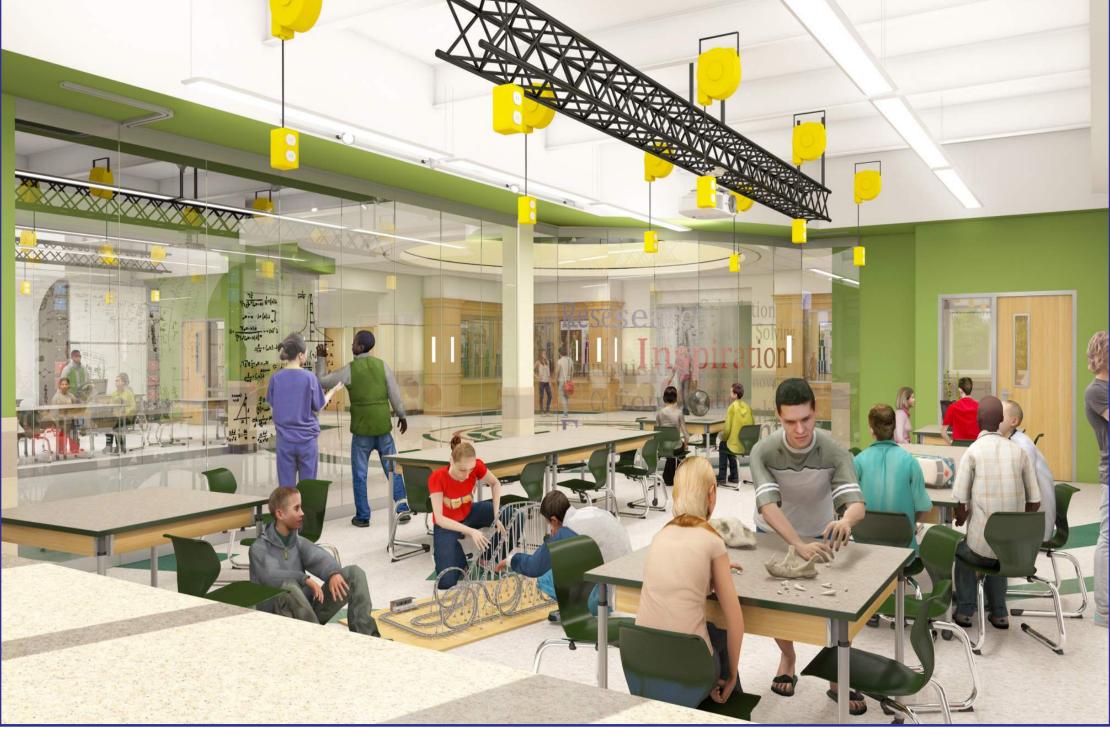
Coakley Middle School - Resolution
S.T.E.A.M. Facilities & Project Labs

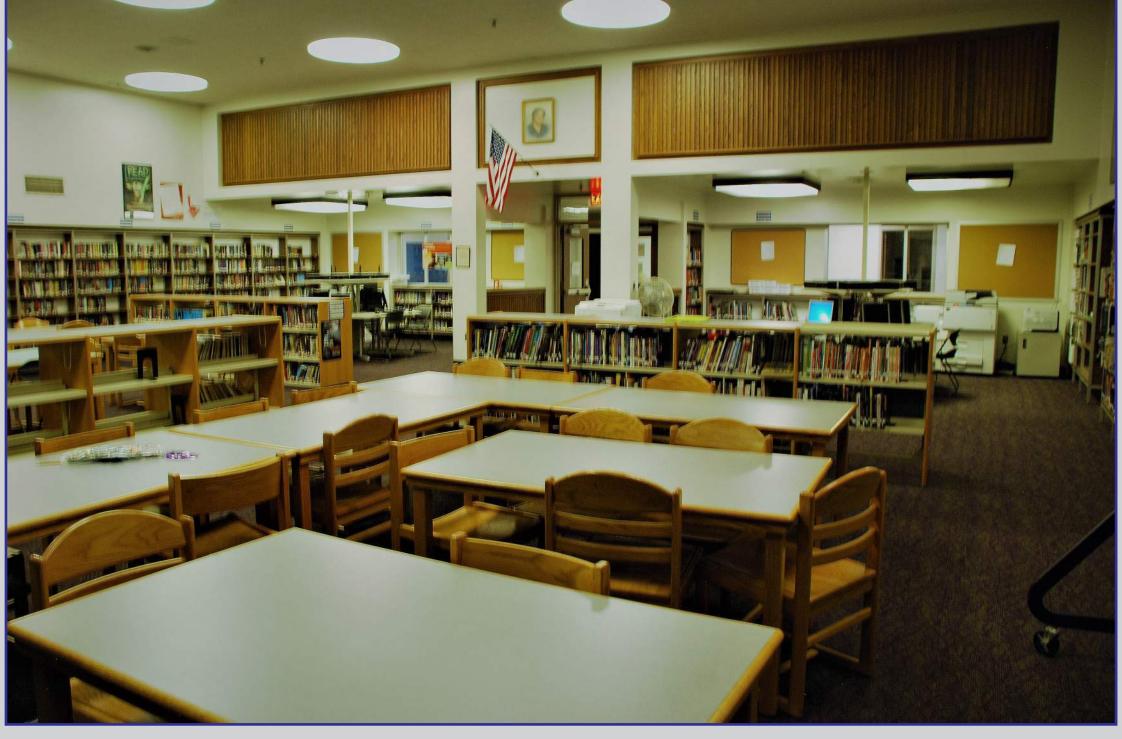
Coakley Middle School - Educational Deficiency Media Center & School Resources

- No integration of digital media, broadcasting, video/web production, digital publishing, or modern resources
- No 1:1 technology program, which would operate via wi-fi and eliminate obsolete computer labs
- No variation in research methods or work stations for either students or staff

- ✓ Library/media center that operates as a highly advanced media retrieval center
- ✓ Located in close proximity to all academic functions to allow for key sharing of valuable resources
- ✓ Advanced technologies provided for in areas such as media production, digital arts, graphic design, and digital communication

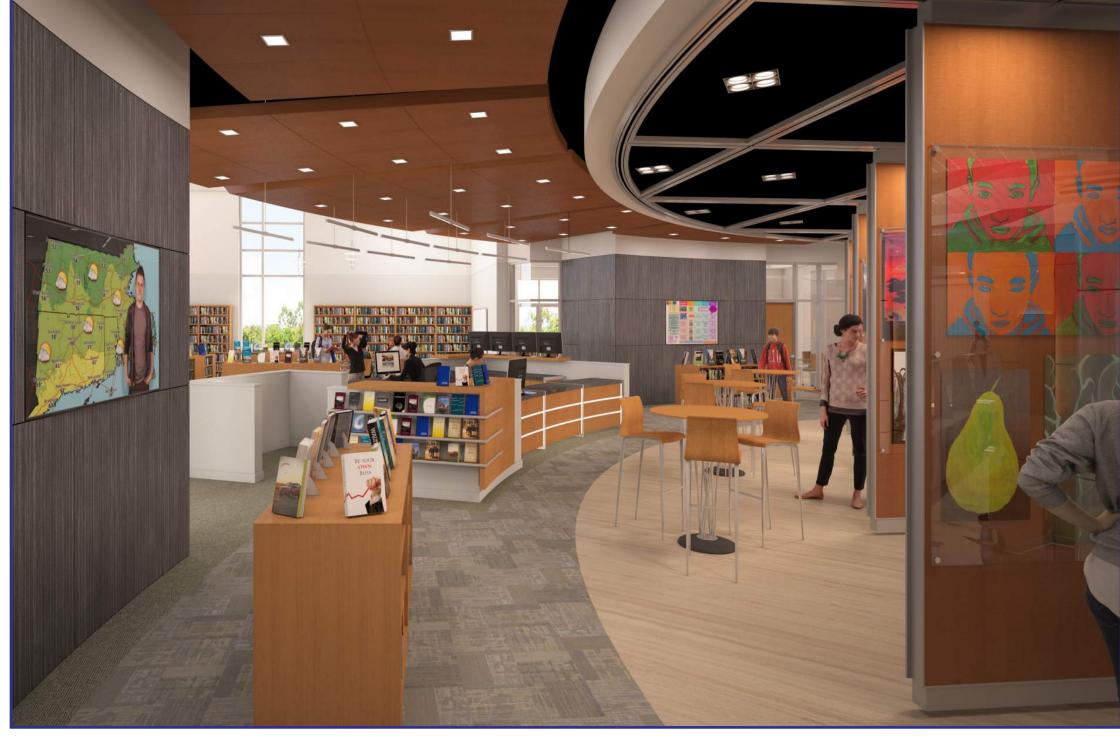
✓ Serves a multitude of functions and is composed of a multitude of spaces media center

Coakley Middle School - Resolution

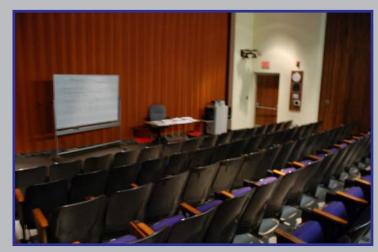
- **No** acoustical materials of an appropriate sound transmission class
- No work surfaces for class use
- Not a welcoming place of assembly
- **Not** used for community performance events or seminars

Coakley Middle School - Educational Deficiency
Performance & Language Arts

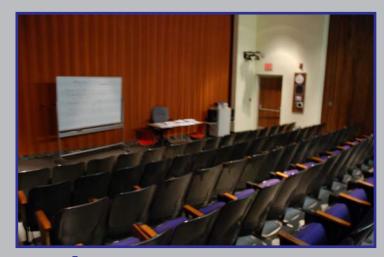
- **No** acoustical materials of an appropriate sound transmission class
- No work surfaces for class use
- Not a welcoming place of assembly
- **Not** used for community performance events or seminars

Coakley Middle School - Educational Deficiency
Performance & Language Arts

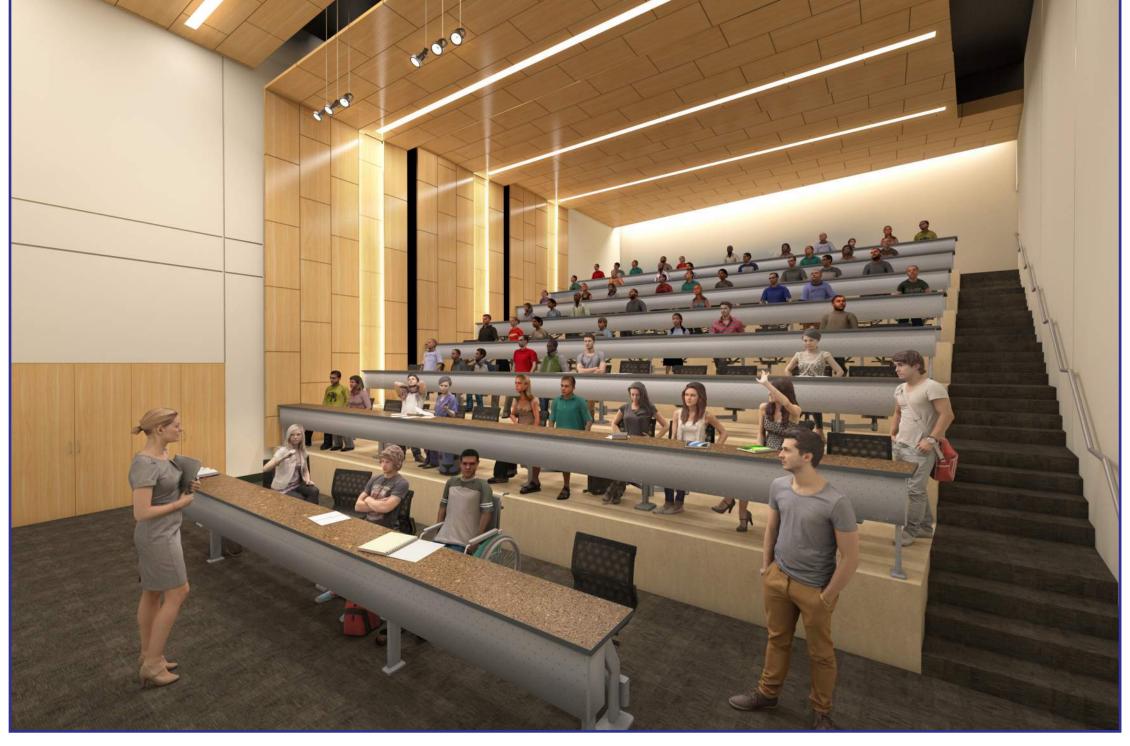
Coakley Middle School - Resolution
Performance & Language Arts
